# **Debris/Ice/TPS Assessment and Integrated Photographic Analysis of Shuttle Mission STS-81**

*Process Engineering/Mechanical System Division/ET-SRB Branch,  
Kennedy Space Center, Florida*

**12 January 1997**

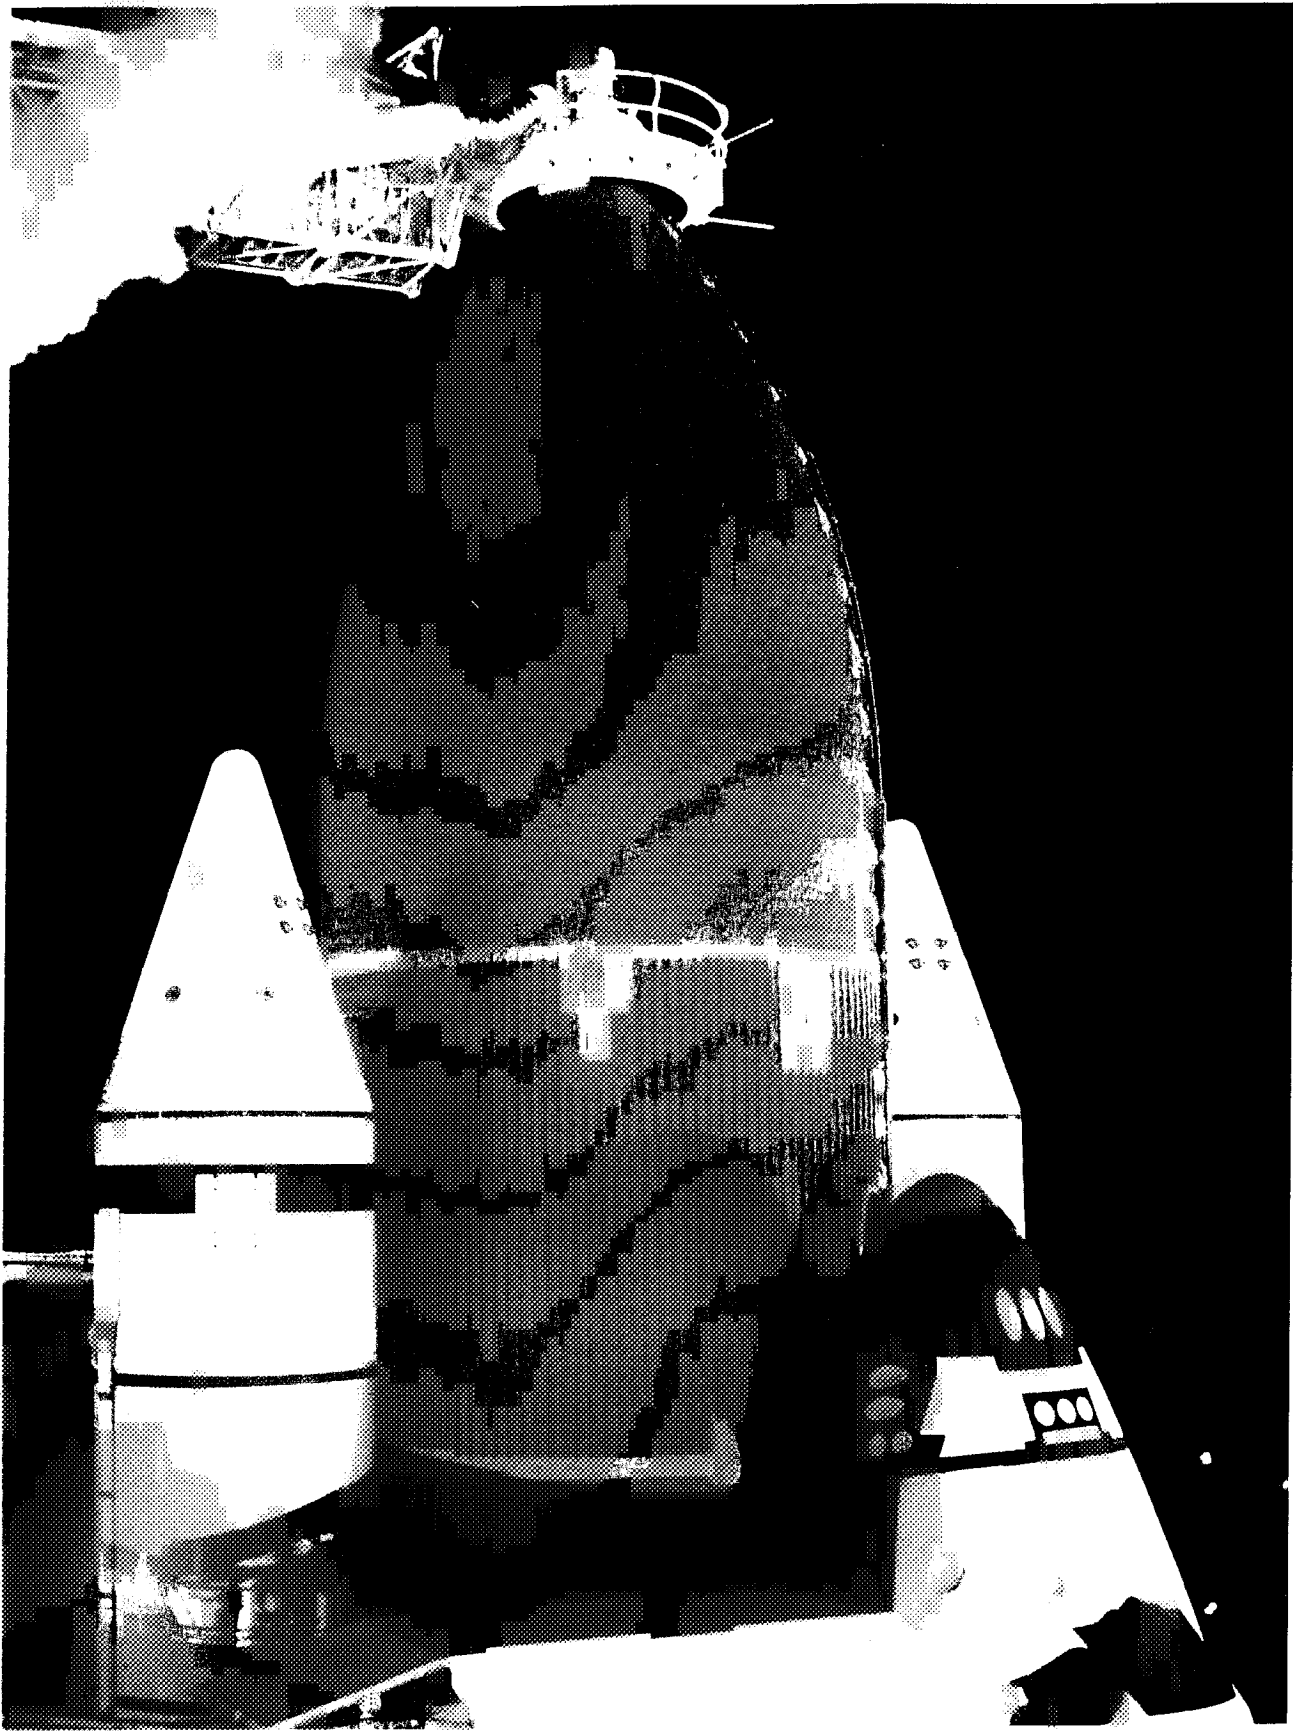
**Photo 4: ET LO2 Tank and Intertank**

Light condensate and isolated patches of frost, but no ice accumulations, were observed on the LO2 tank. TPS surface temperatures ranged from 31 degrees F (in the frosted areas) to 41 degrees F (on the ogive).

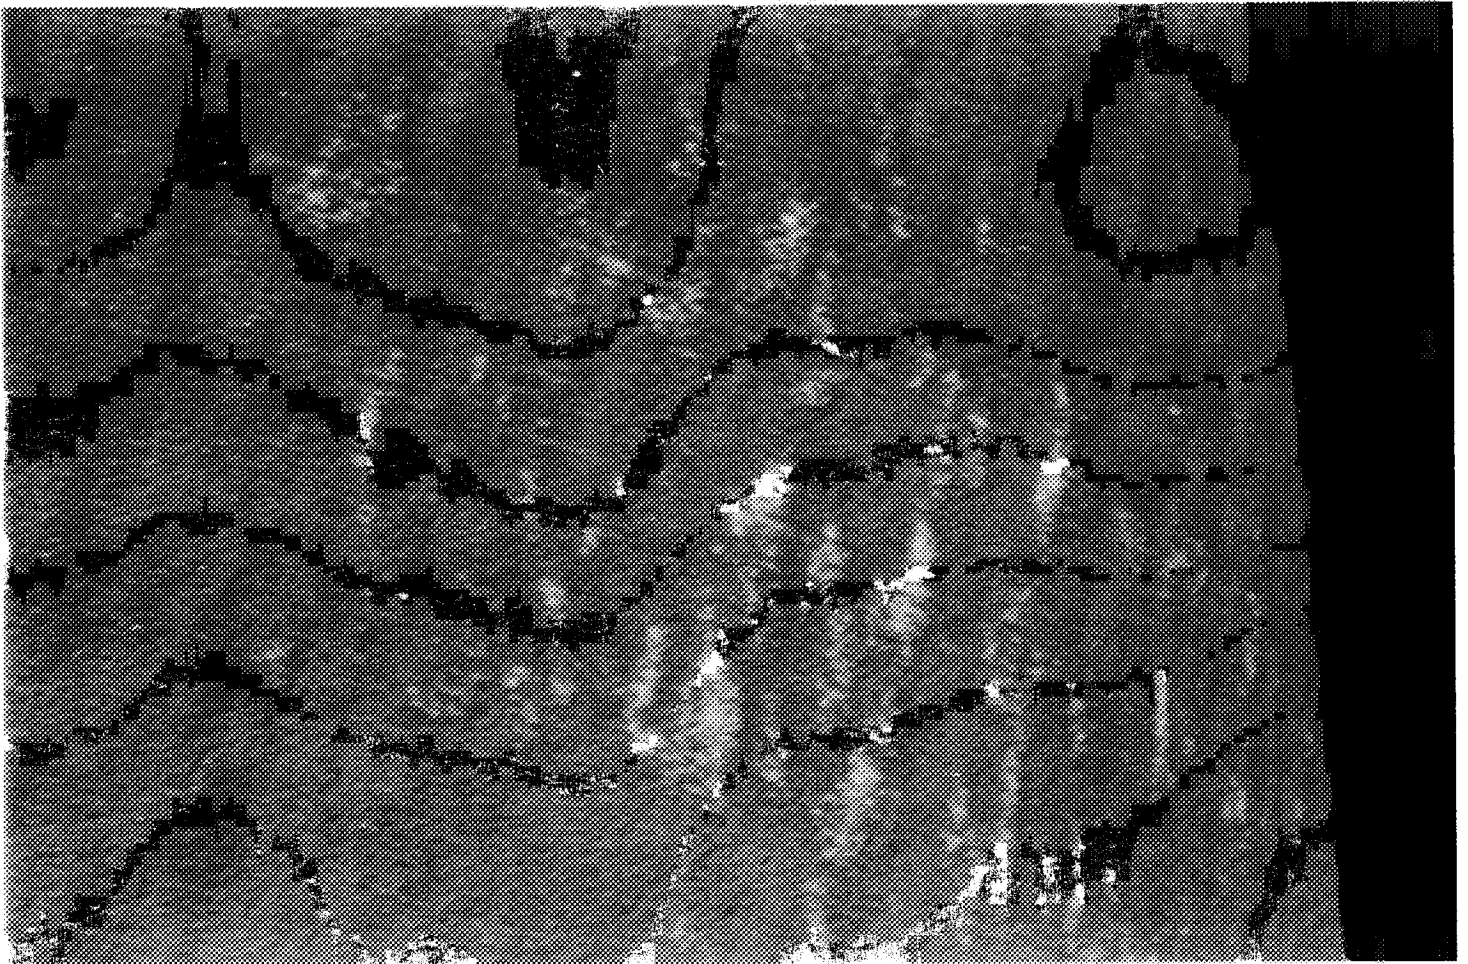
**Photo 5: ET LO2 Tank Frost Patch**

Isolated patches of frost formed on the LO2 tank.

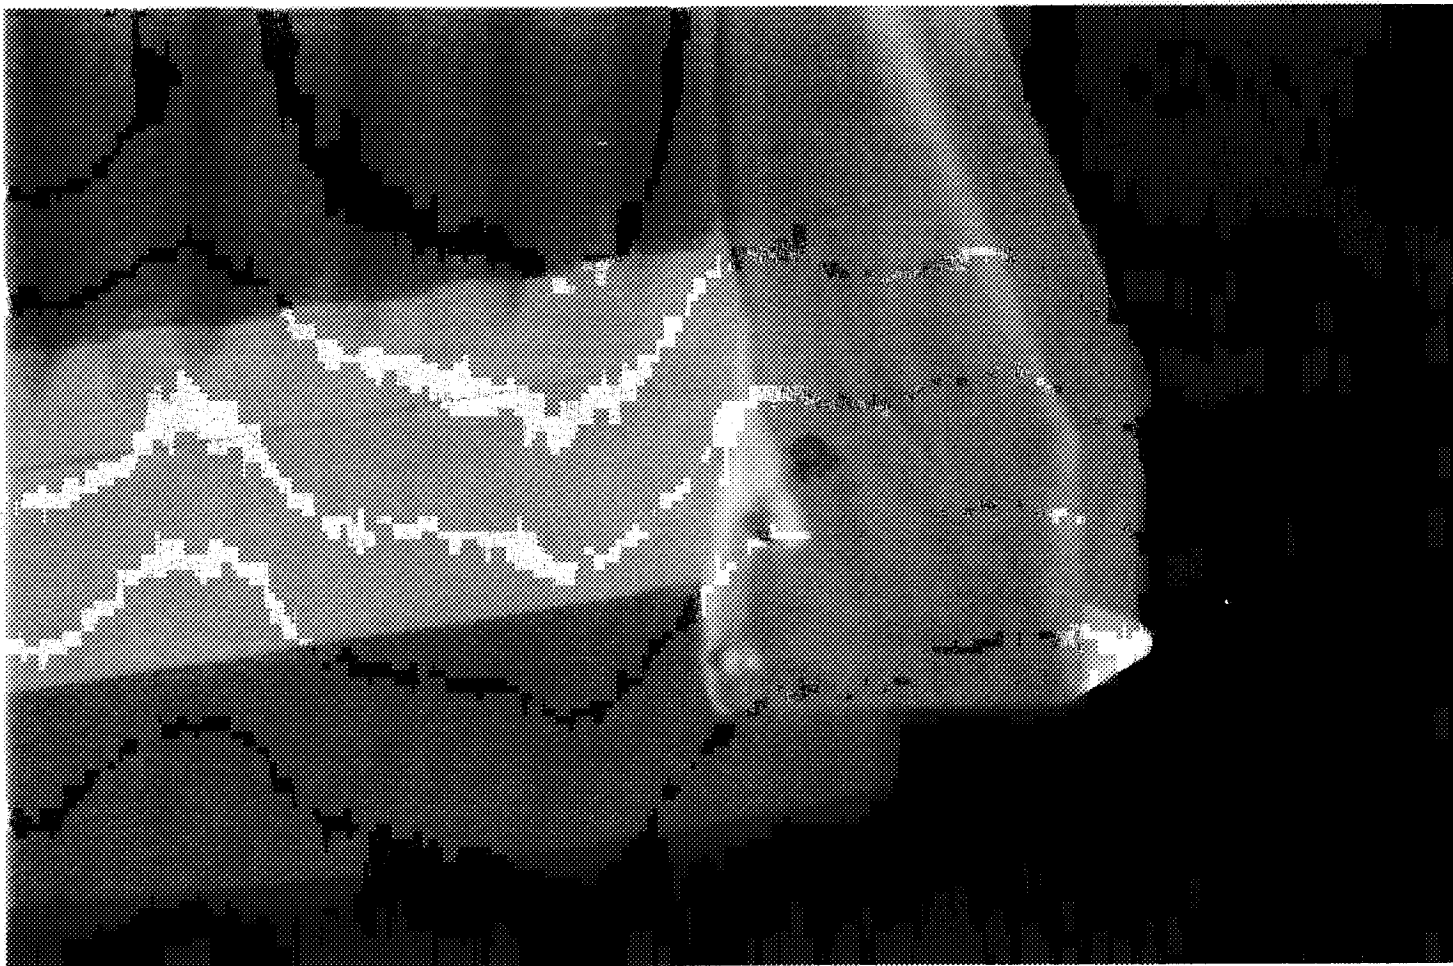
**Photo 6: Frost on Bipod Spindle Housing Closeout**

The Final Inspection Team observed light-to-moderate condensate, but no ice or frost accumulations, on the LH2 tank. TPS surface temperatures ranged from 33-36 degrees F as measured by the infrared radiometers. Frost lines were visible along the bipod spindle housing closeouts, PAL ramps, and cable tray ramps.

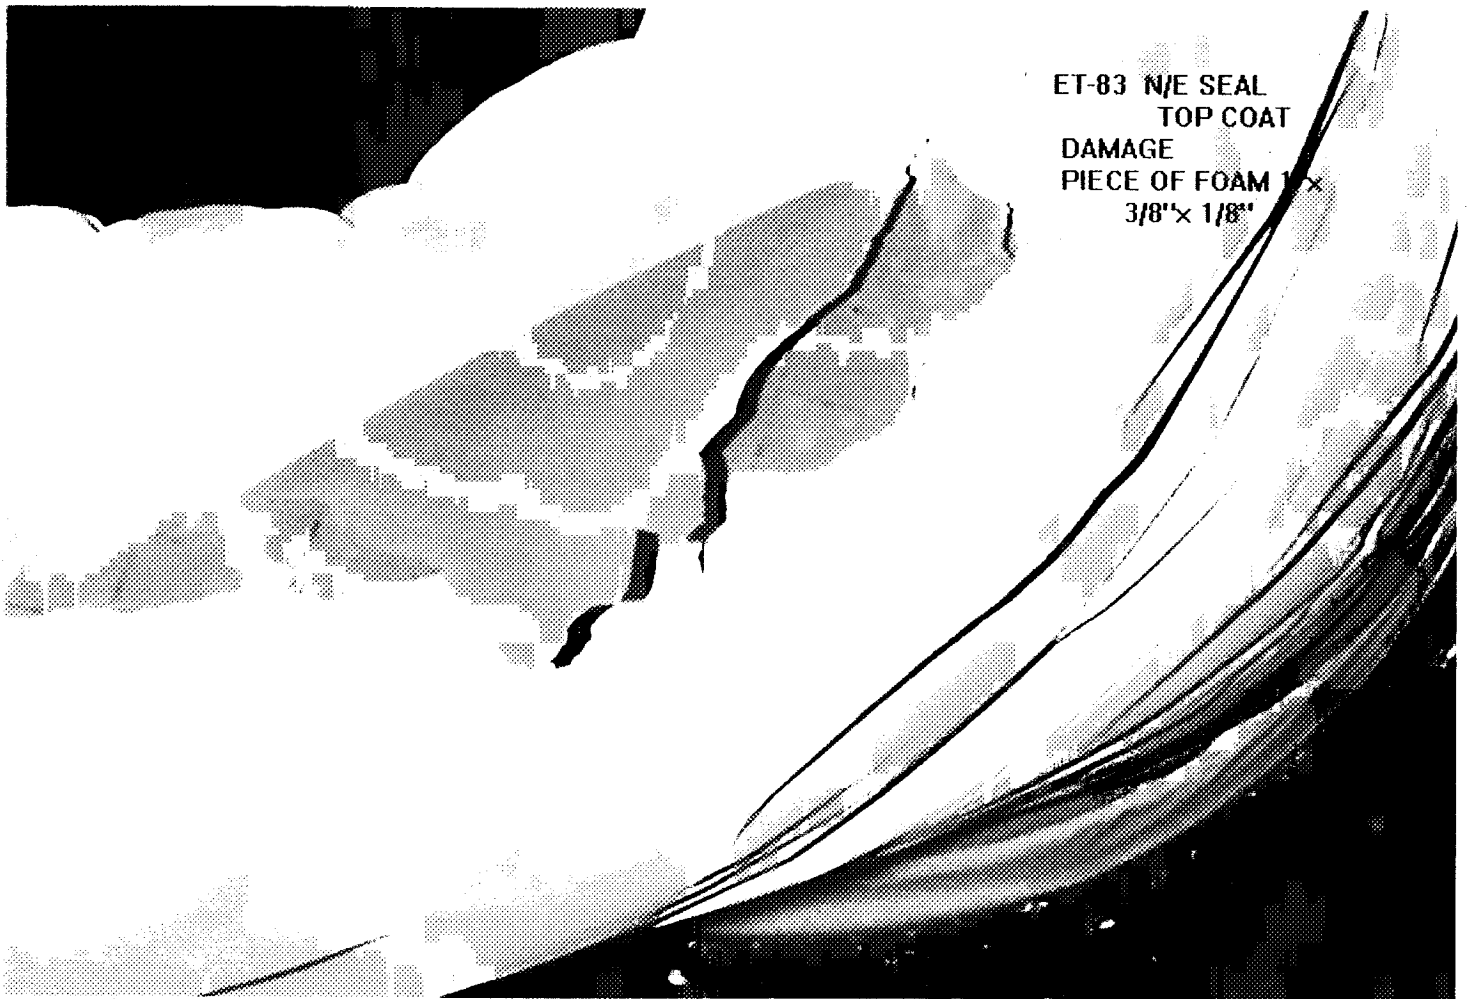
**Photo 7: Topcoat Adhered to GOX Vent Seals**

ET-83 N/E SEAL  
TOP COAT  
DAMAGE  
PIECE OF FOAM 1" x  
3/8" x 1/8"

Minor damage to the ET nosecone/footprint area was visible after the GOX vent hood was retracted. An 8-inch long by 6-inch wide piece of ET topcoat along with a small piece of TPS, 1-inch long by 3/8-inch wide by 1/8-inch thick, adhered to the lower right side of the northeast GOX vent seal.

An 8-inch long by 6-inch wide piece of ET topcoat along with a small piece of TPS 1-inch long by 3/8-inch wide by 1/8-inch thick adhered to the lower right side of the northeast GOX vent seal. This material had been pulled loose from the ET nose cone during GOX vent hood retraction at T-2:30 minutes.

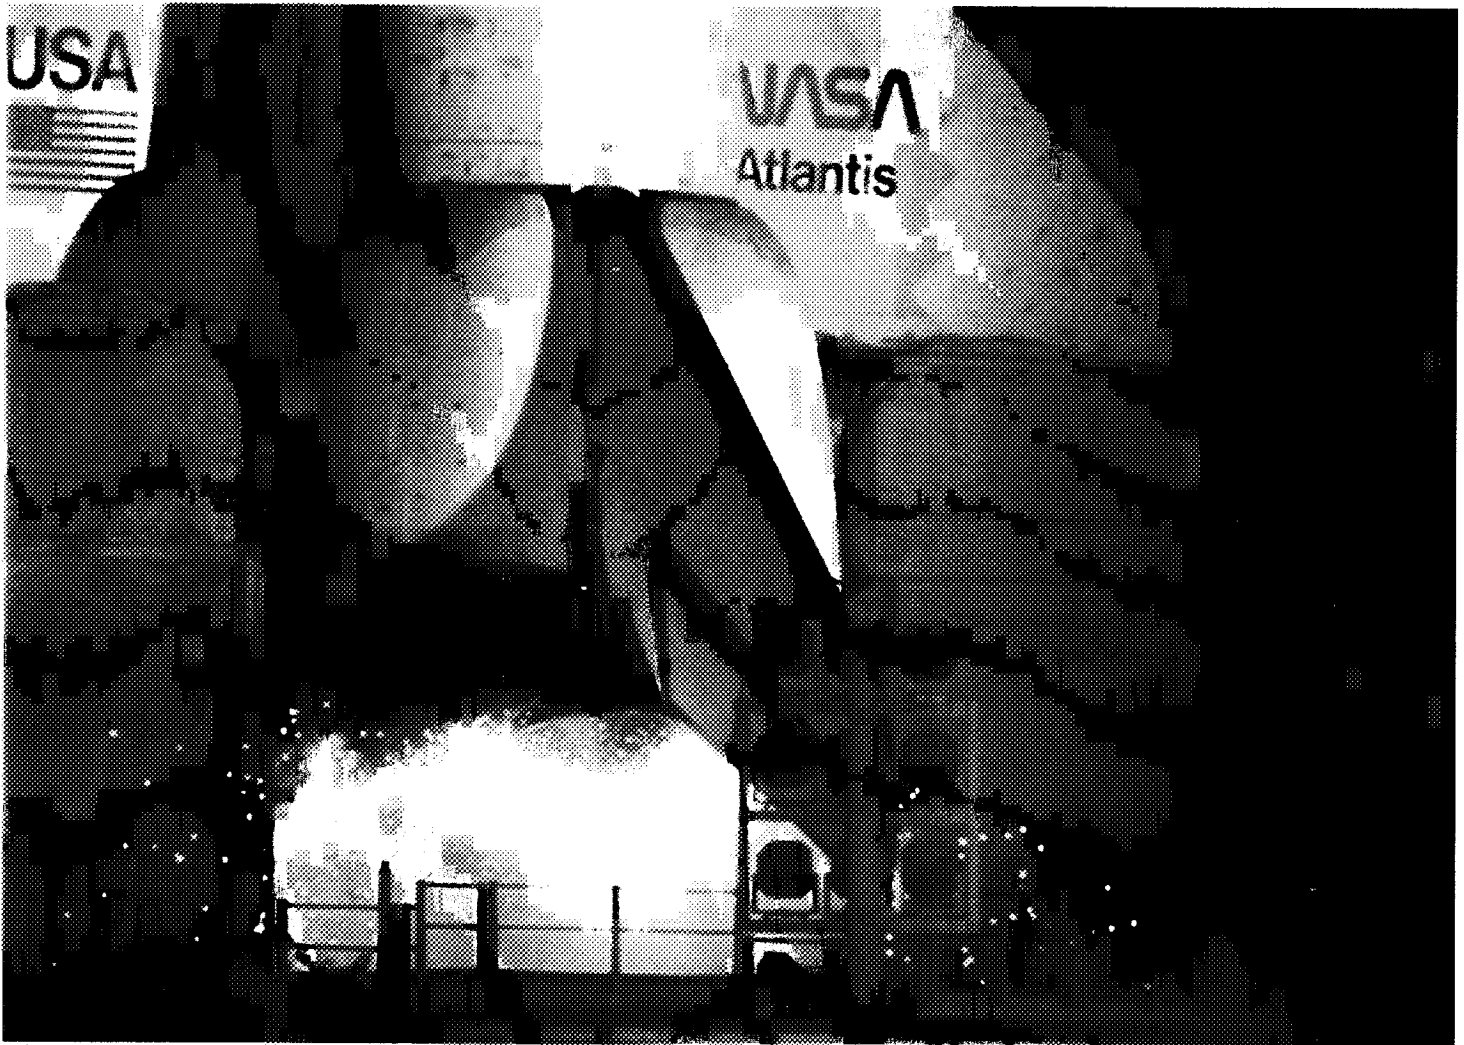
**Photo 8: Green-Tinted Vapors Between SSME #1 and LH2 TSM**

Green-tinted vapors between SSME #1 and the LH2 TSM appeared to be associated with hydrogen igniter activation, but may also have been caused by the green laser illumination test.

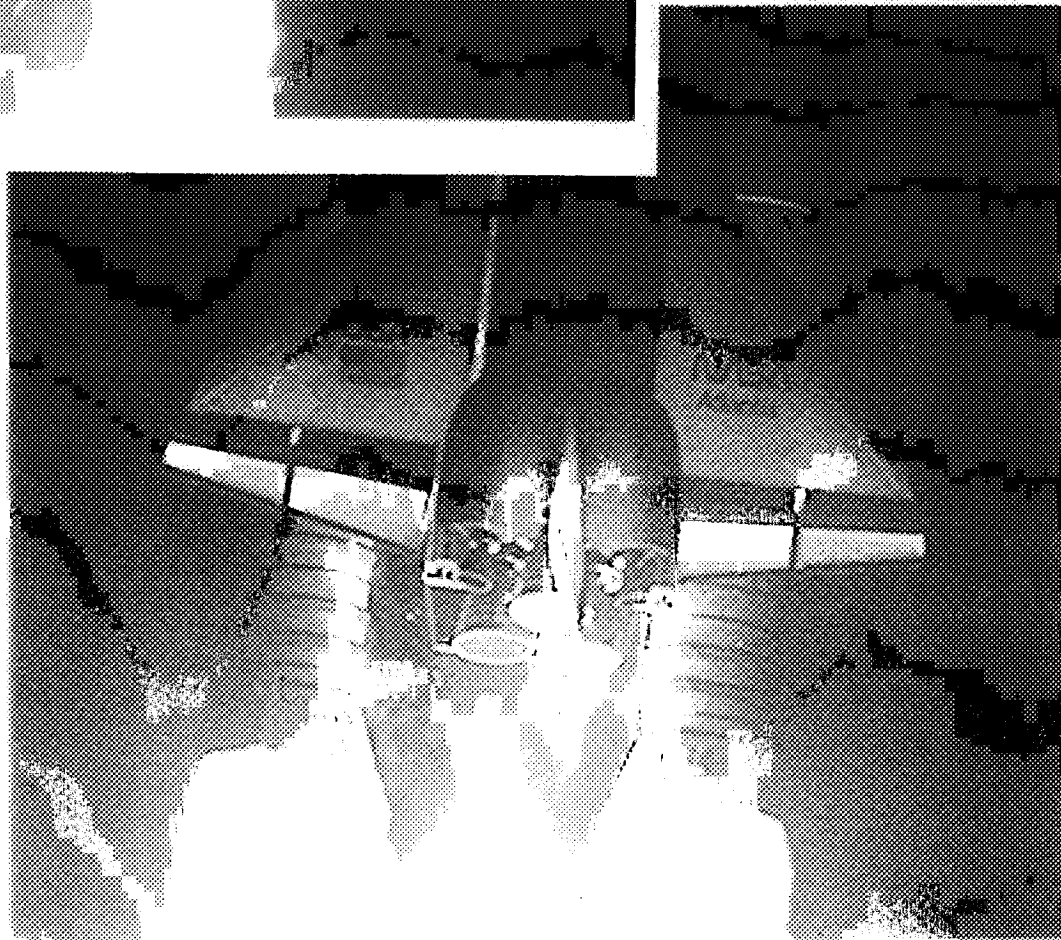
**Photo 10: Loose ET/ORB Umbilical Purge Barrier**

Most of the ET/ORB umbilical purge barrier came loose and fell aft at the beginning of the roll maneuver.

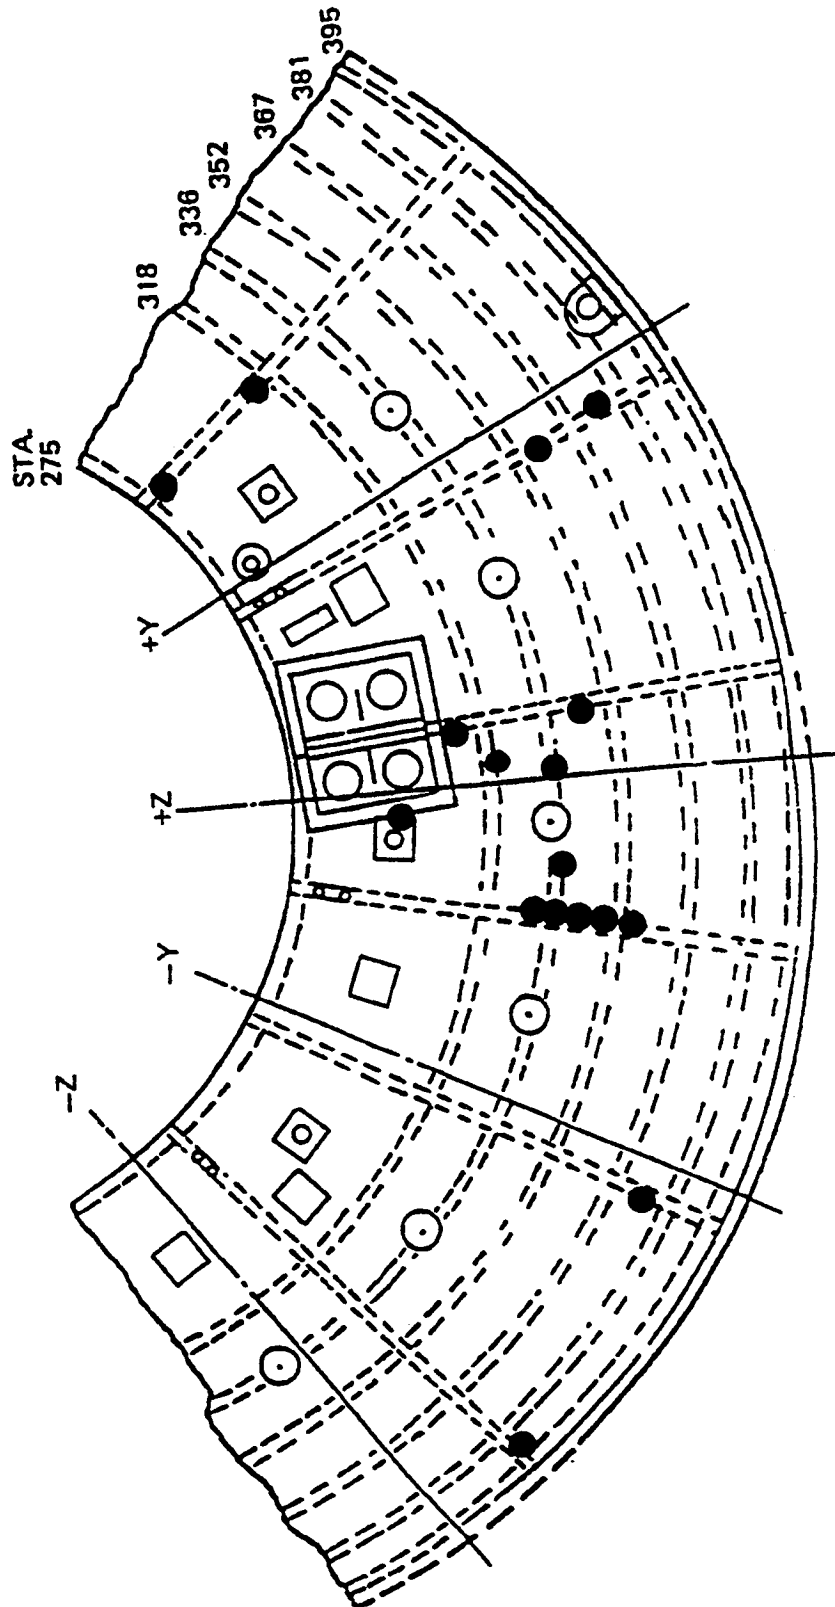
Figure 1: LH Frustum

DEBONDS  
17

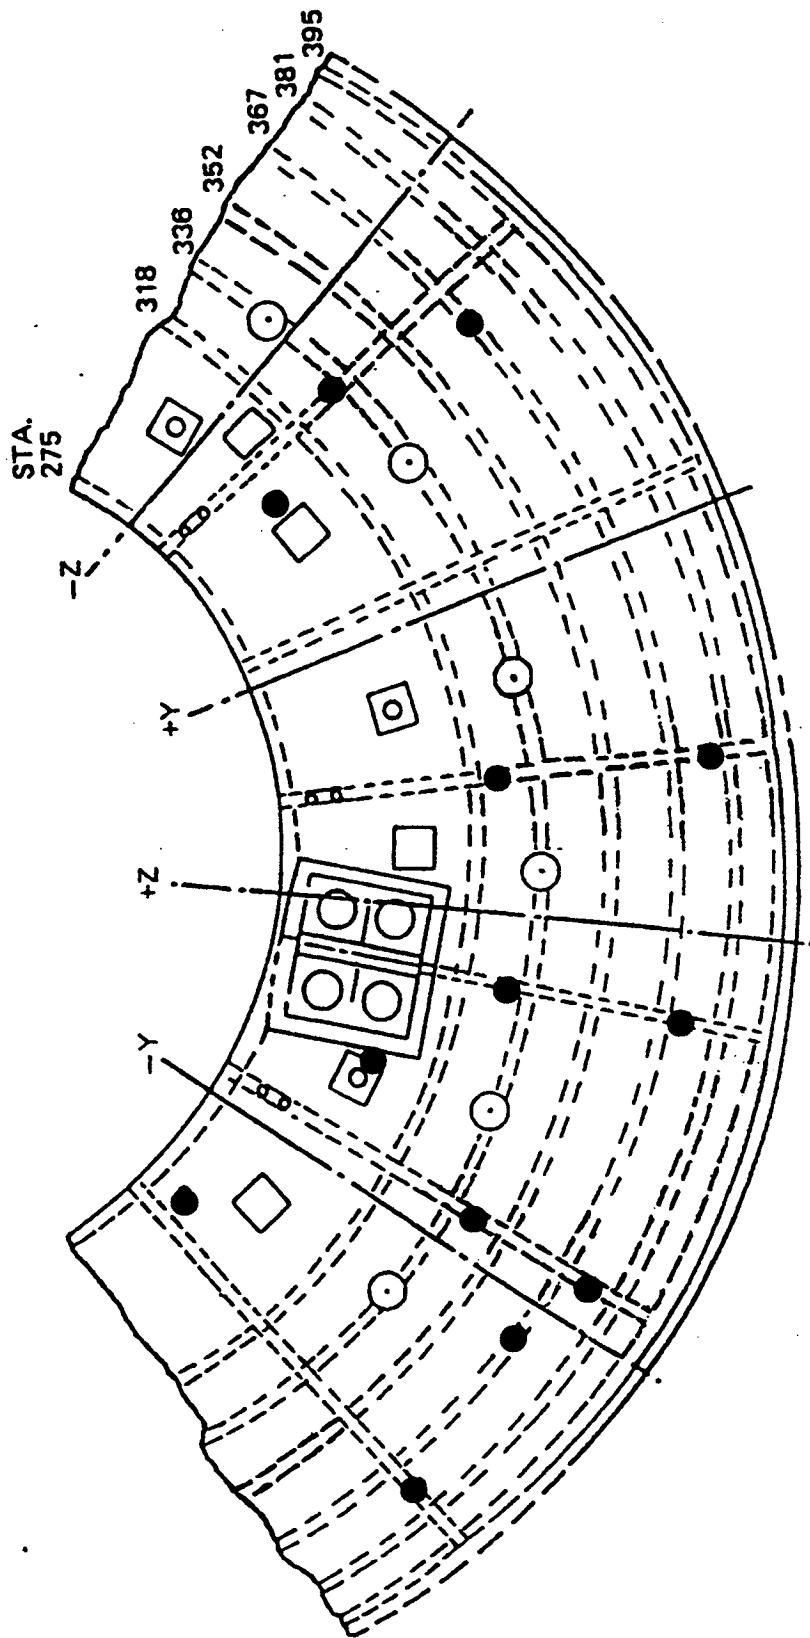
**Figure 2: RH Frustum**

DEBONDS  
13

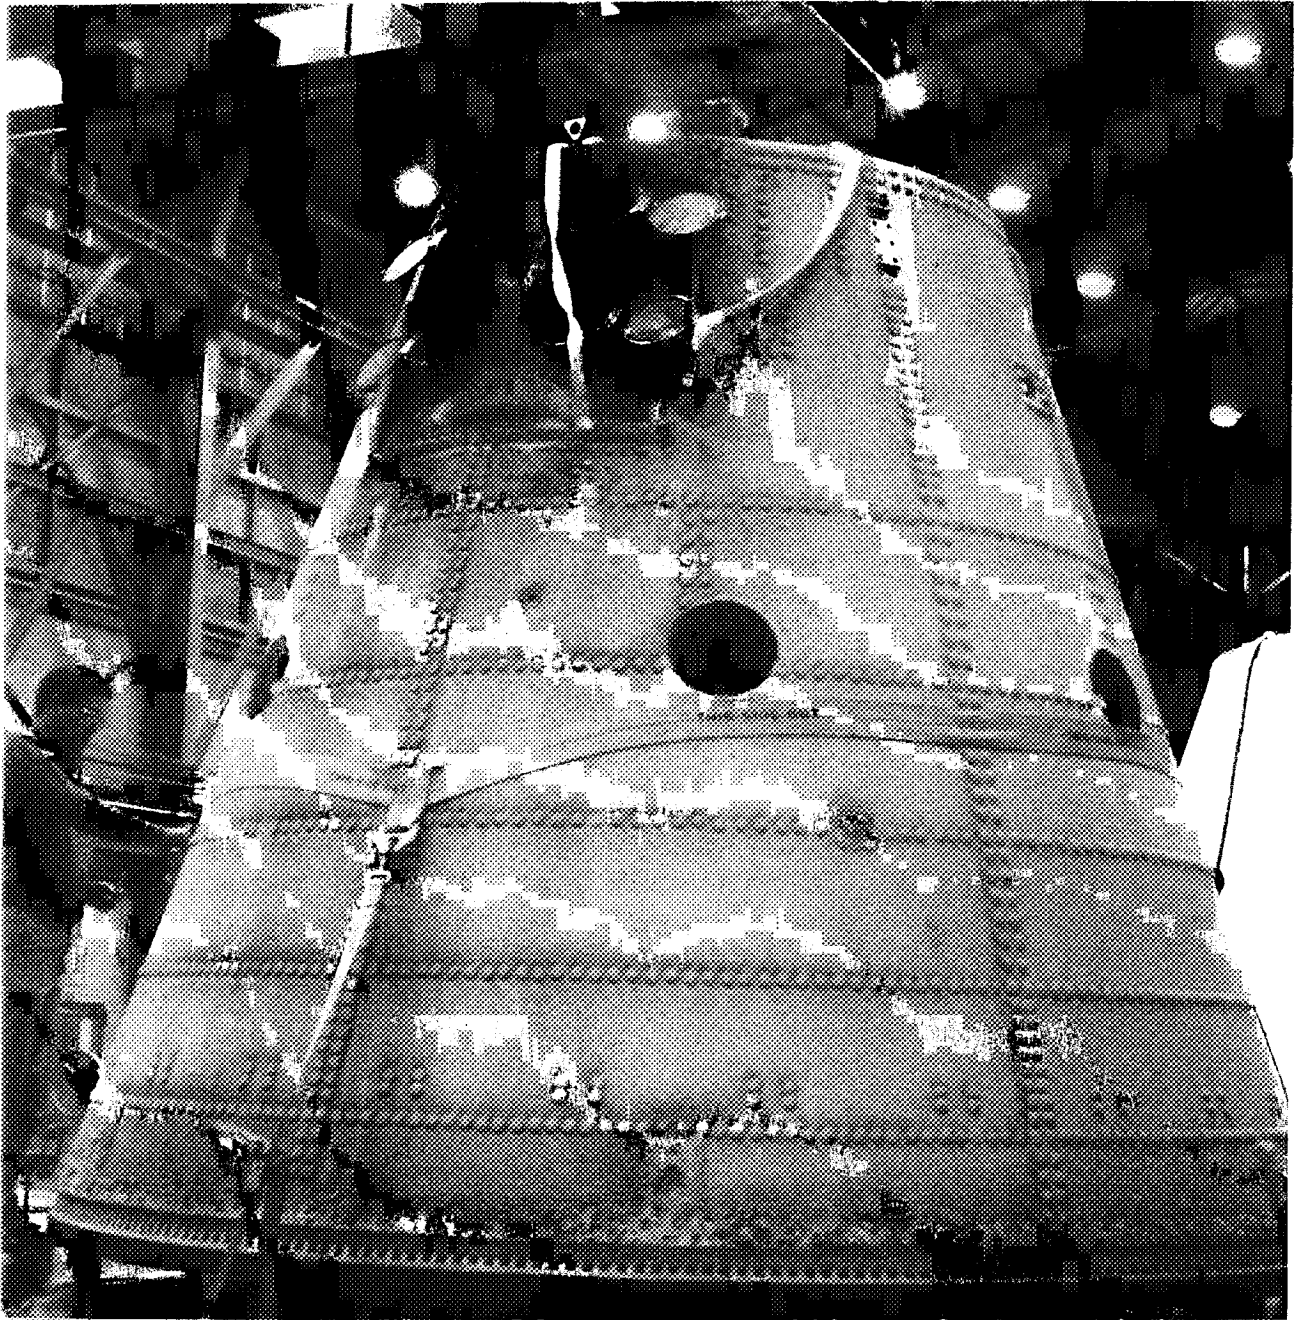
**Photo 13: LH Frustum**

The LH frustum exhibited 17 MSA-2 debonds over fasteners. Hypalon paint was blistered/missing along the XB-395 ring frame. All four BSM aero heat shield covers were undamaged and locked in the fully opened position.

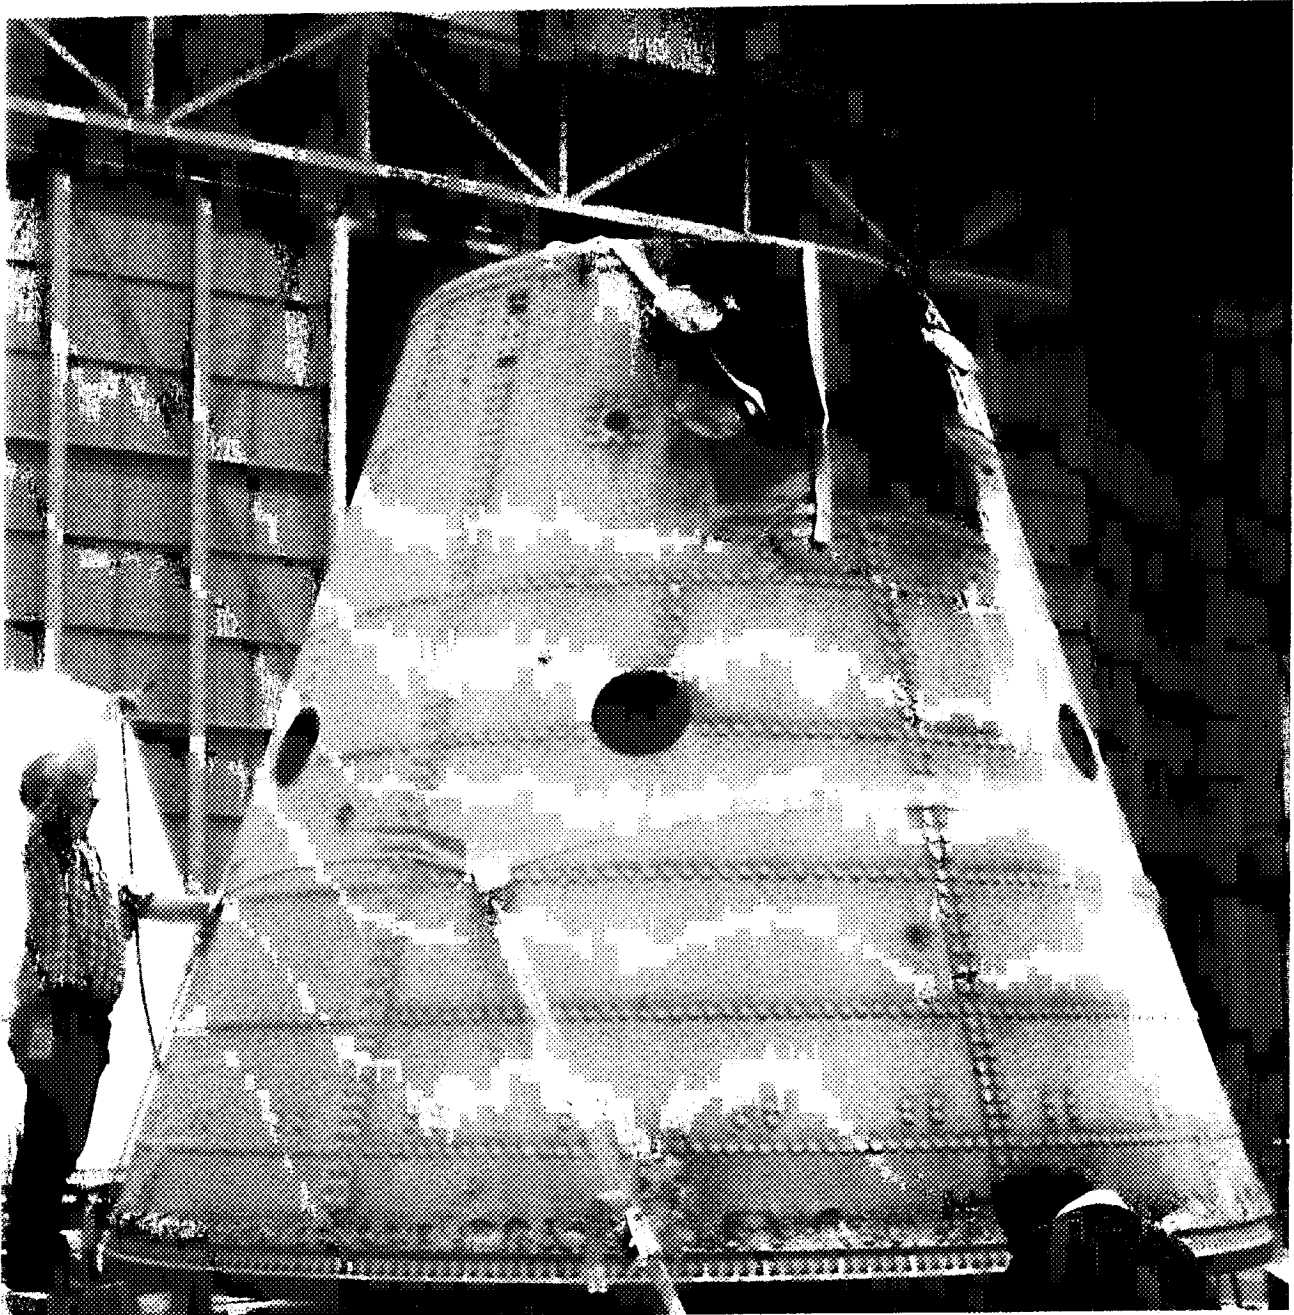
**Photo 14: RH Frustum**

The RH frustum exhibited 10 debonds over fasteners and three debonds over acreage. Hypalon paint was blistered/missing along the XB-395 ring frame. All four BSM aero heat shield covers were undamaged and locked in the fully opened position.

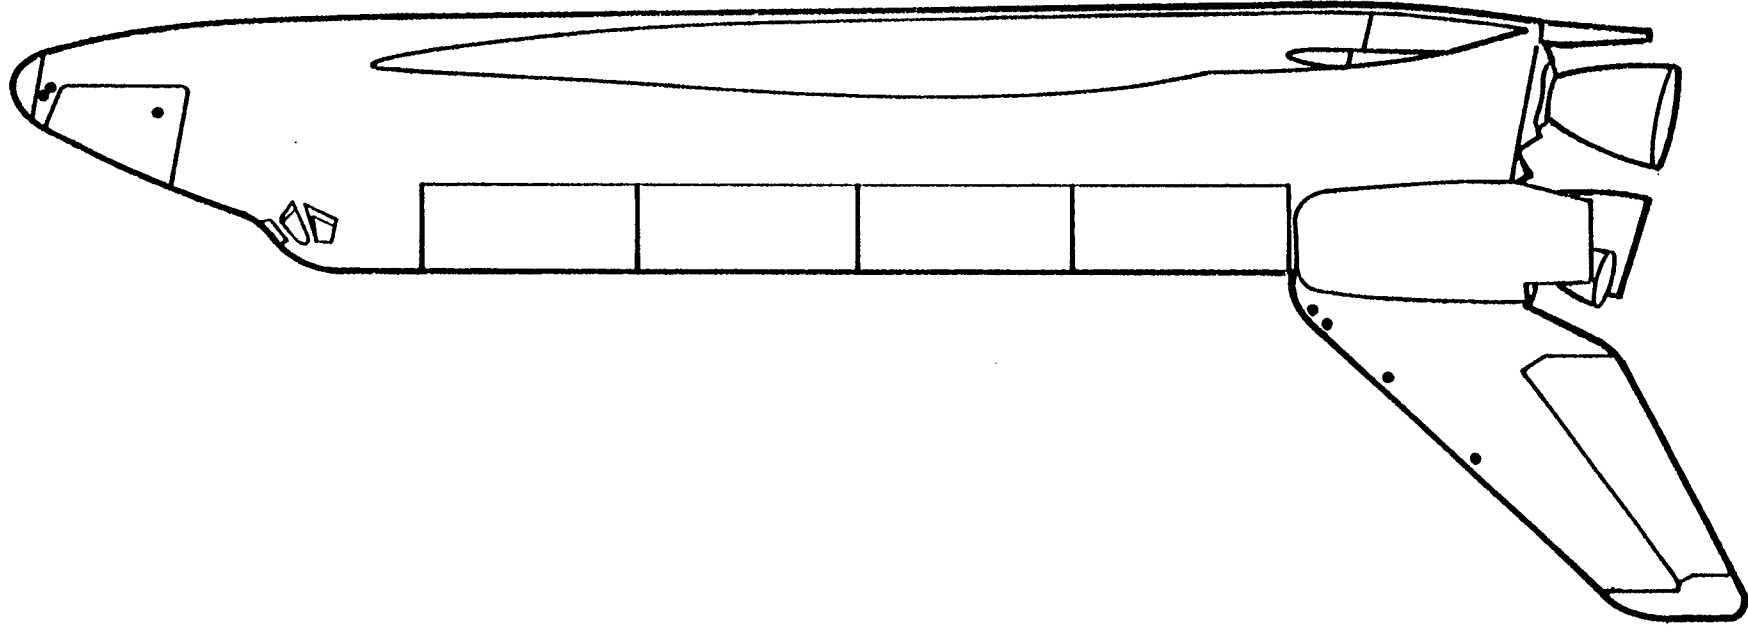
Figure 4: Orbiter Right Side Debris Map

TOTAL HITS = 7  
HITS > 1 INCH = 0

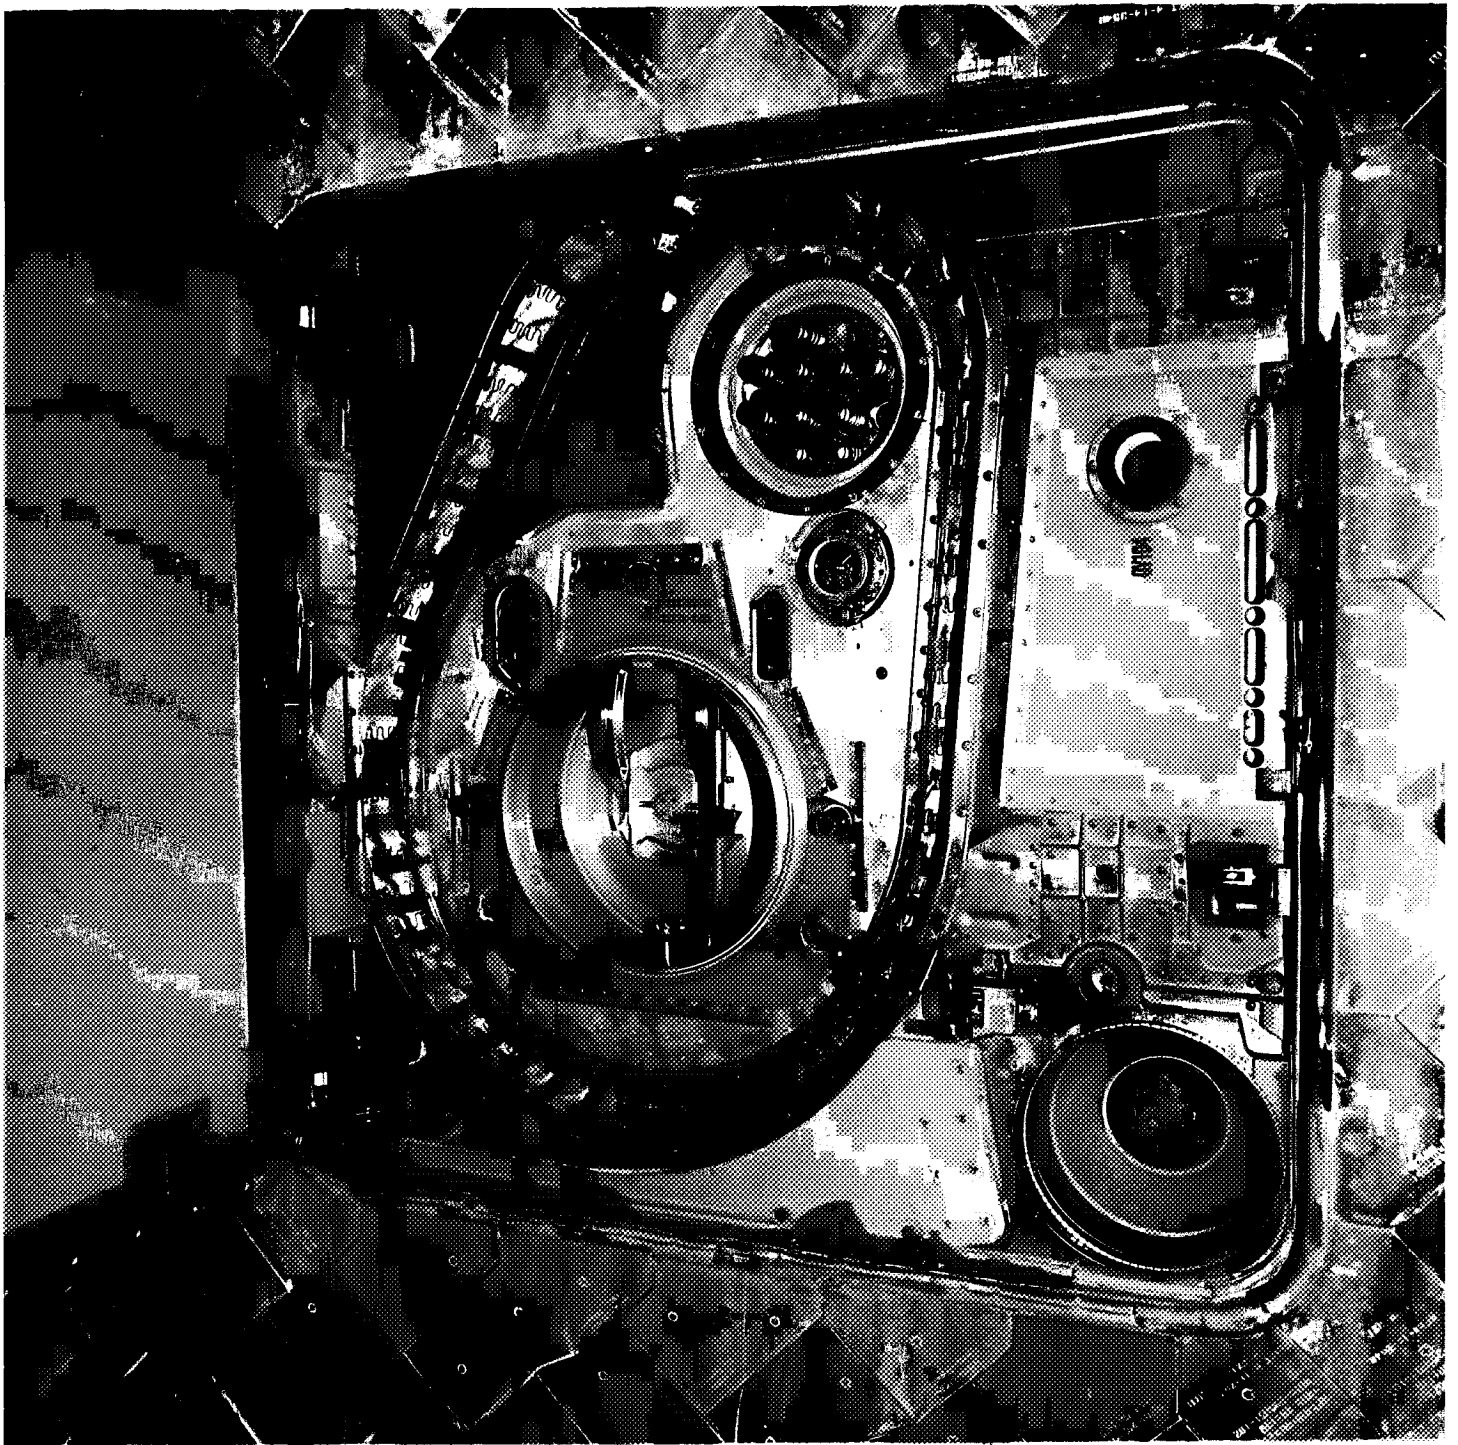
**Photo 24: LO2 Umbilical**

Two spring clips were missing from the EO-3 "salad bowl"

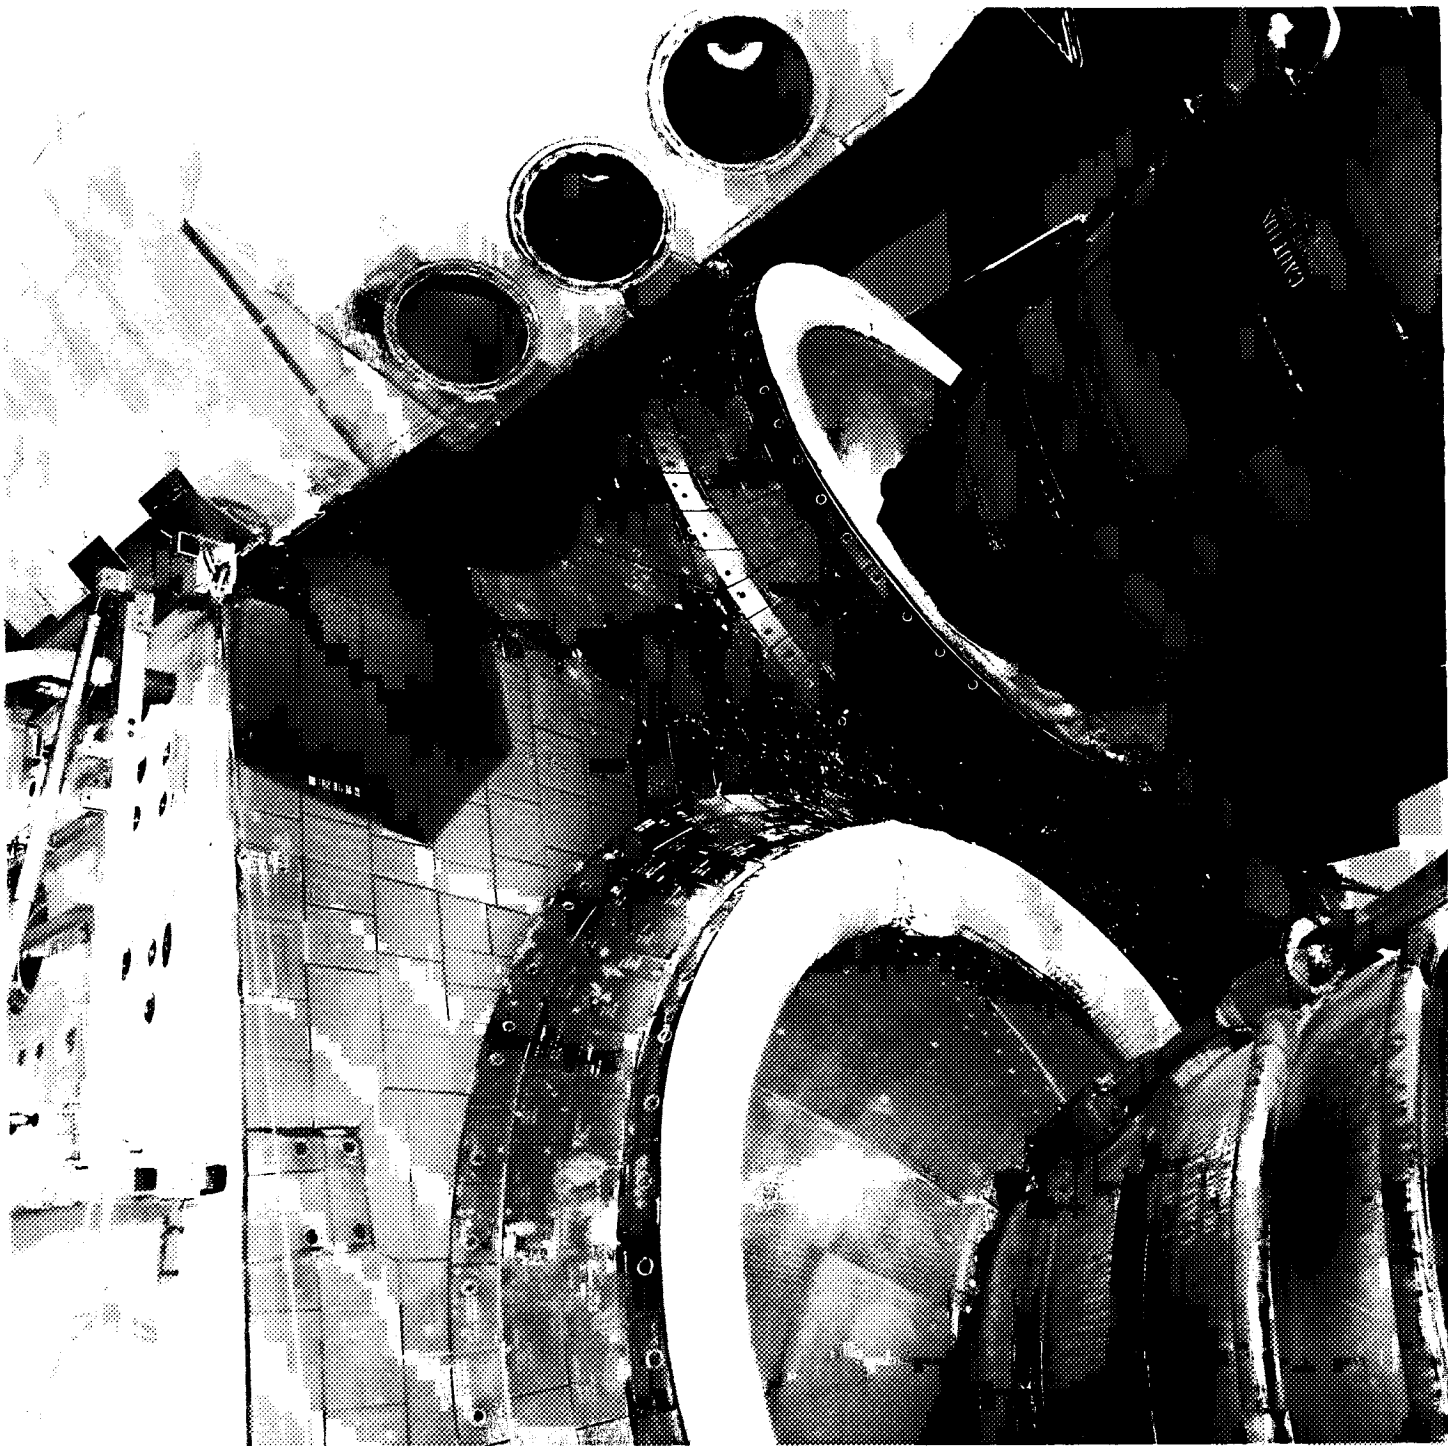
**Photo 26: DMHS Blanket Damage**

The SSME #1 blankets were torn/frayed at the 7:00-8:00 o'clock position.

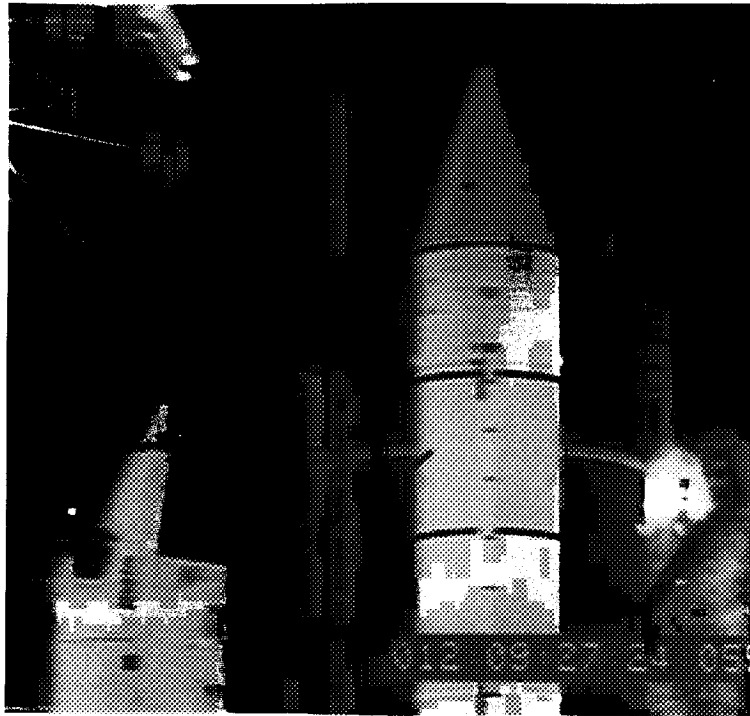
Figure 2.1 (B) Debris Near ET LO2 Feedline

Three pieces of light-colored debris (probably ice) were seen falling aft between the Orbiter and the ET during liftoff (27:25.188 UTC). This debris was first seen near the forward end of the LO2 feedline. The debris was not seen to contact the vehicle. No damage was noted. (Camera E34, KTV7B)

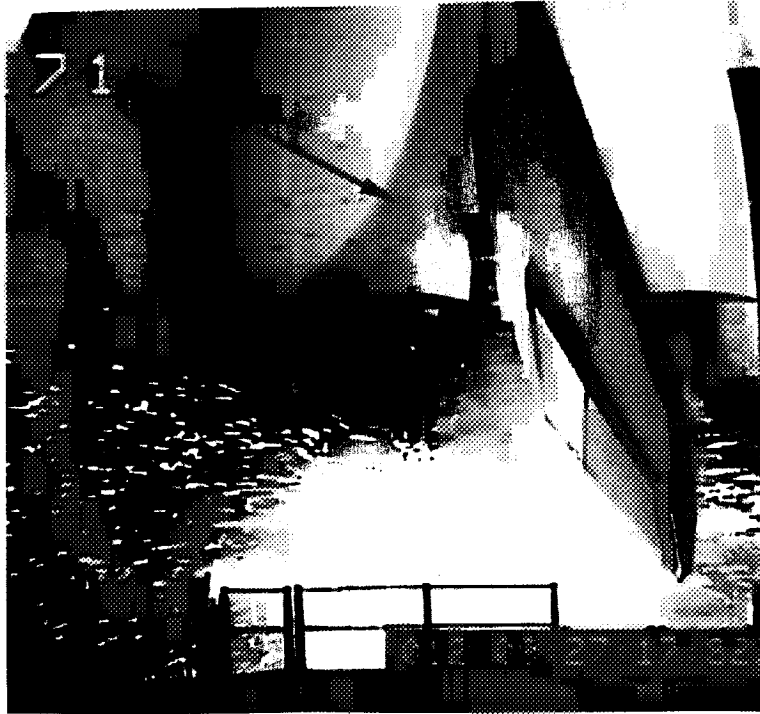
Figure 2.2 (A) Orange Vapor Seen During SSME Ignition

Orange vapor, probably free burning hydrogen, was seen above the SSME rim exit plane, near the body flap, and along the vertical stabilizer during SSME ignition (09:27:17.7 UTC). Orange vapors have been seen on previous missions. (Cameras OTV170, OTV171, E2, E4, E5, E17, E19, E20, E36, E52, E76)

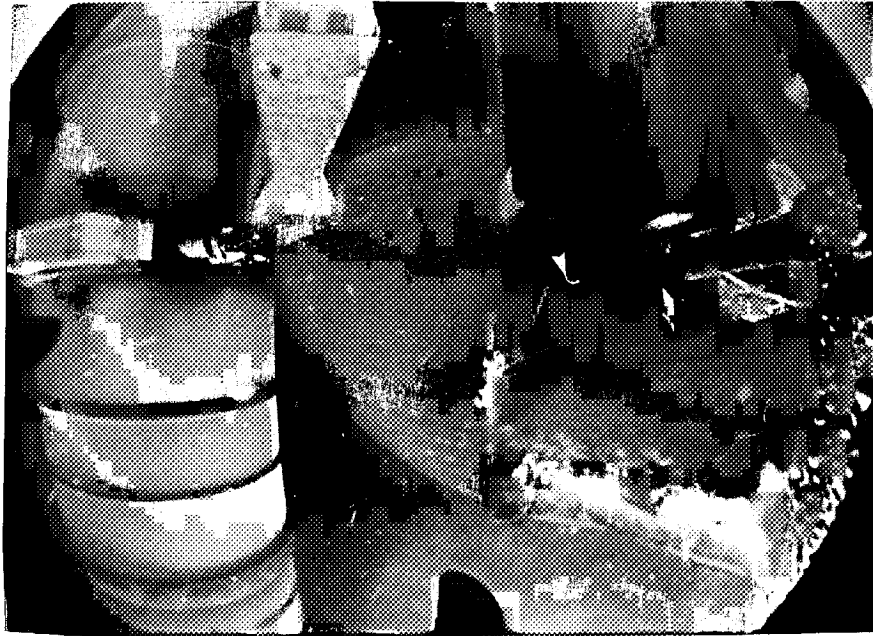
Figure 2.4.1 (A) Debris Striking LH2 Electric Cable Tray

Numerous light-colored pieces of debris (probably insulation) and dark debris (probably charred insulation) were seen throughout the SRB film sequence. Typical ablation and charring of the ET/Orbiter LH2 umbilical electric cable tray and the aft surface of the horizontal section of the -Y ET/SRB vertical strut was seen. Ablation of the TPS on the aft dome was less than was seen on STS-80. The charring of the ET aft dome TPS was typical of previous missions. A light-colored piece of debris (probably a piece of insulation) was seen to strike the LH2 electric cable tray. No damage was noted. The LSRB separation appeared normal. The 16mm films had good focus and good exposures. Timing data is present on the umbilical well films.
